Manhole Inspection Summary

Manhole # S05AA2031MH

Location Address: **6002 WESTERN RUN DR** Cross Street: **BAYWOOD AVE**

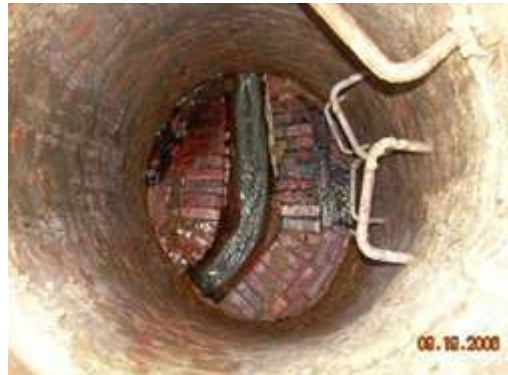
Top View

Adjustment and Corbel infiltration.
Corroded steps. Evidence of surcharge -
Bench debris.

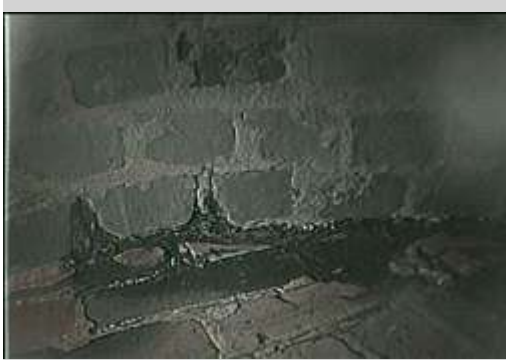
Defect

Barrel Material: **Brick** ☐ Parged
Shape: **Circular** Diameter: **42** (in.) Length: (in.)
Condition: ☐ Sound ☐ Cracked ☐ Root Intrusion ☐ Loose Brick ☒ **Deteriorated**
Infiltration: ☐ None ☐ Joint ☐ Cracks ☒ **Mortar** ☐ Roots ☒ **Wall**

Barrel deterioration and infiltration.

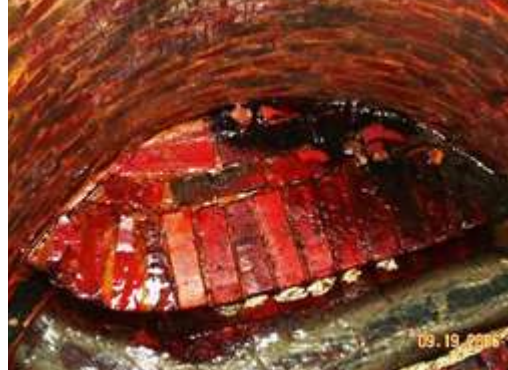
Defect

Barrel infiltration. Channel grease
deposits.

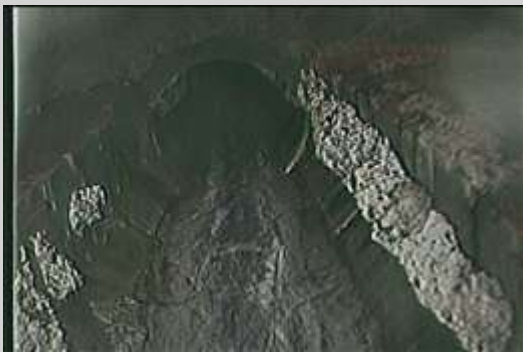
8 in. Circular Gravity Sewer Pipe Out @ 12 O'Clock

Comments **The O12 pipe picture chows Channel has grease deposits. The I7 pipe seal is not flush to the pipe.**

Infiltration: **None** Pipe Seal Cond: **Cracked**
